Manhole Inspection Summary

Manhole # S31UU_002MH

Location Address: **322 29TH ST**

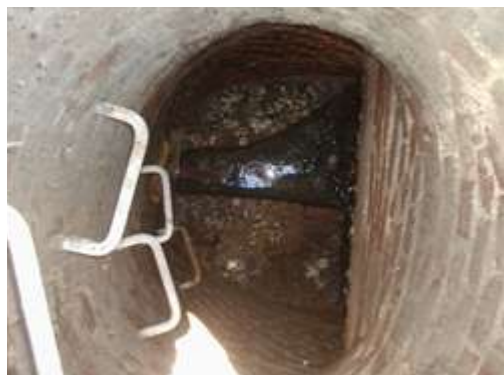
Top View

Corroded steps. Bench and Channel debris.

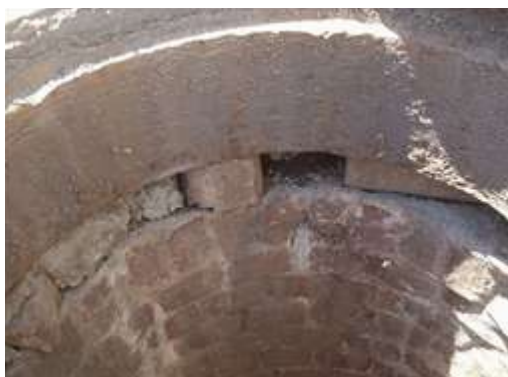
Defect

Frame leaks. Adjustment deterioration, loose brick and infiltration - other side.

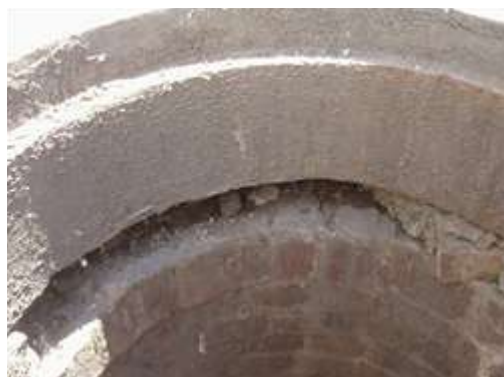
Defect

Frame leaks. Adjustment deterioration, loose brick and infiltration.

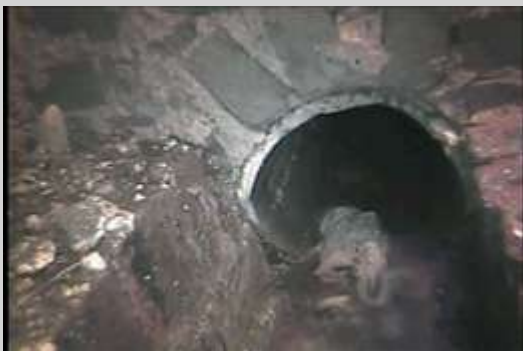
8 in. Circular Gravity Sewer Pipe In @ 6 O'Clock

Deposits: ☐ None ☐ Mud ☐ Sludge ☒ **Debris** ☐ Grease

Silt Depth: **0** (in.) Deposits Extent: **Light**

Infiltration: **Evidence** Pipe Seal Cond: **Unknown**
